**IRON MOUNTAIN LAKE DAM
ST FRANCOIS COUNTY, MISSOURI
MO 30057**

PHASE 1 INSPECTION REPORT NATIONAL DAM SAFETY INSPECTION

APRIL 1981

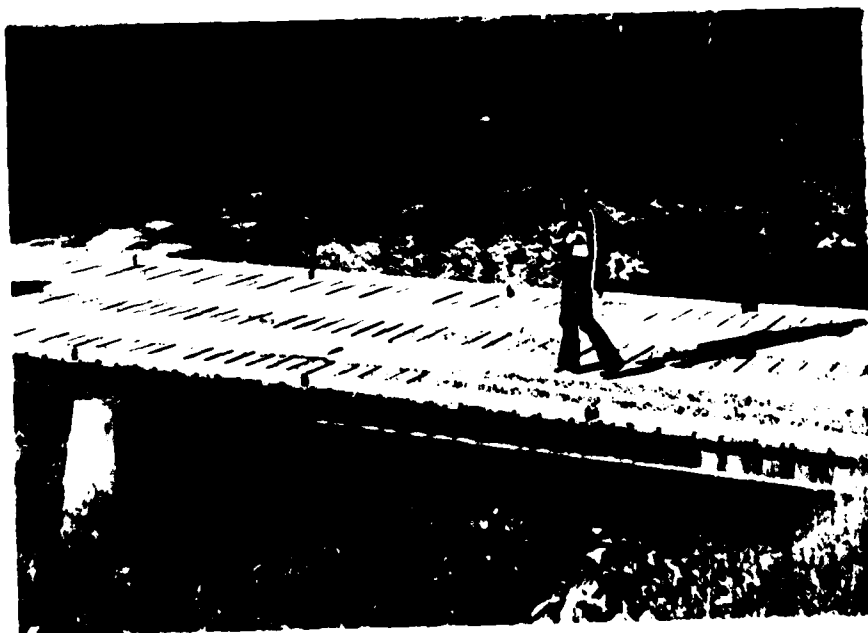
8. Plank bridge over main spillway discharge
channel. Looking downstream (north).
